Manhole Inspection Summary

Manhole # S41A__019MH

Insp Date: **6/26/08 11:38 AM**

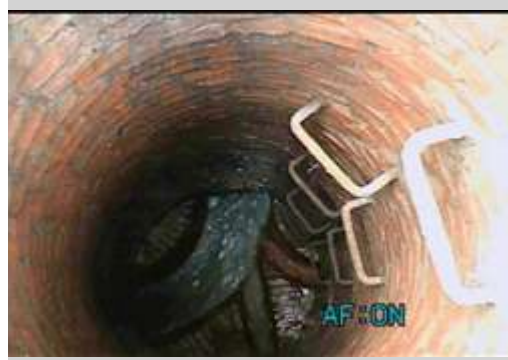
Top View

top view & steps

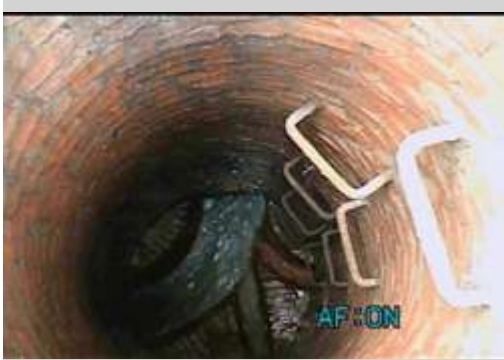
Defect 2

Count: **8** Missing: **0** ☒ **Corroded**

corroded steps

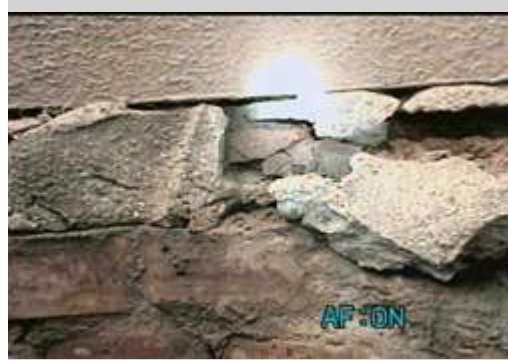
Defect 1

☒ Exists Material: **Brick and Concrete** ☐ Parged Height: **4** (in.)

Condition: ☐ Sound ☒ **Cracked** ☐ Root Intrusion ☐ Loose Brick ☒ **Deteriorated**

cracked deteriorating chimney, frame adj

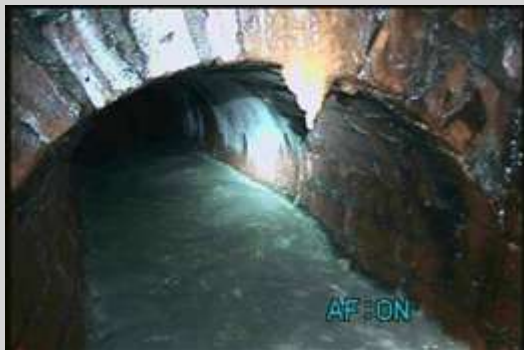
12 O'Clock Outflow

21 in. Circular Gravity Sewer
Pipe Out @ 12 O'Clock

Pipe Material: **Clay** ☐ Pipe Lined

Invert Depth: **14.95** (ft.) Flow Characteristics: **Fast**

Infiltration: **None** Pipe Seal Cond: **Unknown**

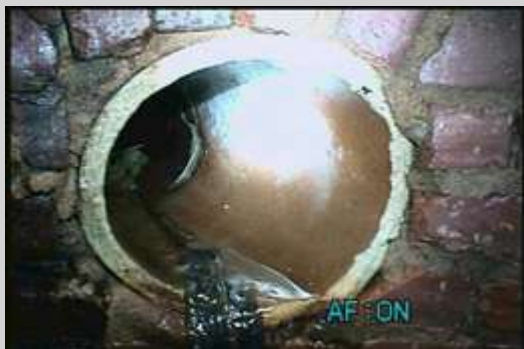
3 O'Clock Inflow

8 in. Circular Gravity Sewer
Pipe In @ 3 O'Clock

Pipe Material: **Clay** ☐ Pipe Lined

Invert Depth: **10.11** (ft.) Flow Characteristics: **Fast**

Infiltration: **None** Pipe Seal Cond: **Unknown**

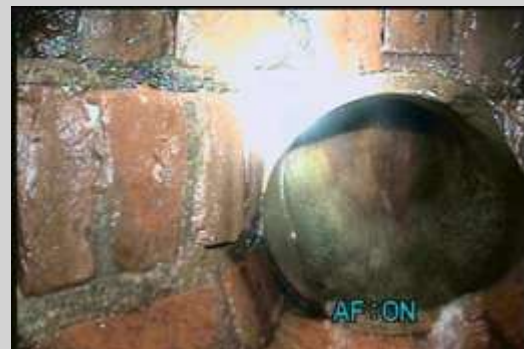
Drop In @ 3 O'Clock

Drop: **Outside Direct**

Inv Depth: **14.10** (ft.)

Drop Condition: **Open**

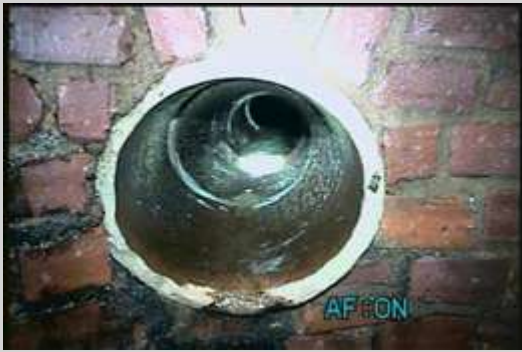
6 O'Clock Inflow

8 in. Circular Gravity Sewer

Pipe In @ 6 O'Clock

Pipe Material: **Clay** ☐ Pipe Lined

Invert Depth: **10.10** (ft.) Flow Characteristics: **Fast**

Infiltration: **None** Pipe Seal Cond: **Unknown**

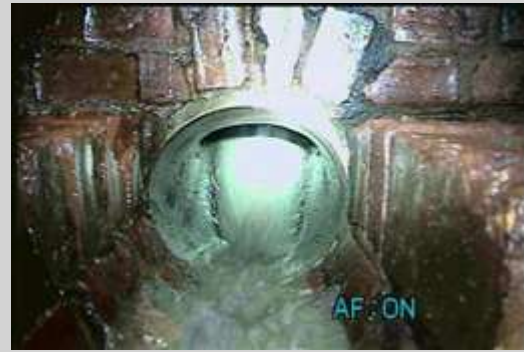
Drop In @ 6 O'Clock

Drop: **Outside Direct**

Inv Depth: **14.15** (ft.)

Drop Condition: **Open**

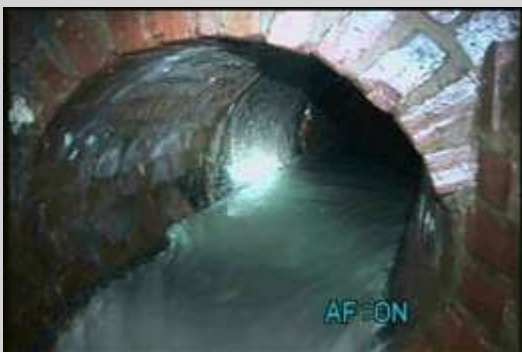
9 O'Clock Inflow

21 in. Circular Gravity Sewer

Pipe In @ 9 O'Clock

Pipe Material: **Clay** ☐ Pipe Lined

Invert Depth: **14.90** (ft.) Flow Characteristics: **Fast**

Infiltration: **None** Pipe Seal Cond: **Unknown**
